STAR ONLINE PUBLICATION

Case Number: S2119000001 Rev A

Symptom/Vehicle Issue: Click Pop Creak Noise While Turning Steering Wheel

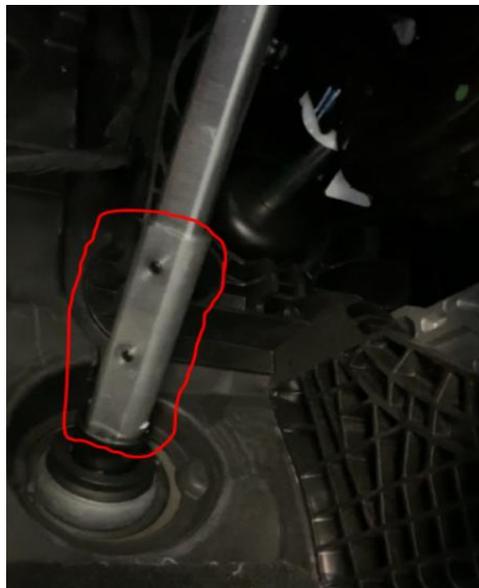
Discussion: For JL/JT and DT built before and MOPAR service columns packaged before 10/15/2020; use a stethoscope to listen to the lower steering shaft while the steering wheel is being turned. Fig 1 shows the dust cover removed to show the energy absorbing slip joint of the steering shaft on the interior side near the front bulkhead. Listen to the joint with the engine running and off. If the noise is originating from this area replace the steering column. The energy absorbing joint is not designed to be serviced or repaired other than replacement as a column assembly.

Fig 1 Steering shaft at the front bulkhead (interior side)
